**Flood Control Project Maintenance
Levee Inspections**
LMA District Cover Sheet
Spring 2018 Levee Inspection Results

Reclamation District No. 2031 Elliot

Waterway			Bank	Unit Miles
Unit No. 01 Stanislaus River			Left	7.07
	Spring (March - May)	Summer (June - August)	(September - November) Fall	Winter (December - February)
Unit Maintenance Rating (Fall Only)				
Date of Inspection	5/16/2018 - 5/16/2018			
DWR Inspector	Sterling York			
Accompanied By	Arvid Carlson RD2031

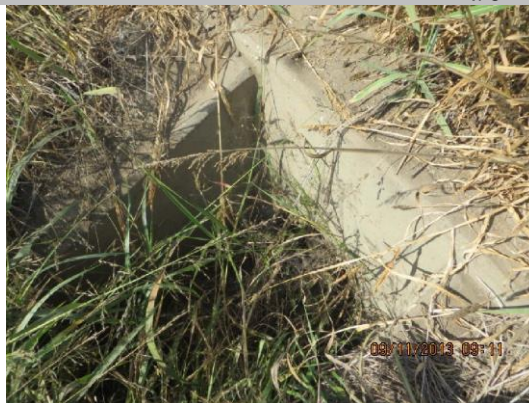
Photo 1 of 2 : UCIP_SP_2018_20024_33924.jpg

LM Start	0.35	Rating **	A/W	Issue No.	983
LM End	0.35	Issue Type +	Ma	Location *	
Category	Supplemental			GPS Latitude/Longitude	
				Start	End
Item	DWR UCIP LMA Responsibility			37.705932 °	37.705932 °
				-121.157985 °	-121.157985 °
DWR ID					
Comment Code					
Inspector Comment					
FS_ID:20024					
DS_ID:20437					
EP_NO: N/A					
Repair Type: No Action Needed					
Crossing Status: Found					
UCIP Comments:					
FIELD_STRUCT_DESC: 24-inch corrugated metal drainage pipe					
through the levee, 3.5 feet below the crown. Concrete U-shaped					
headwalls on both ends. Flap gate on the waterside (WS) end. Installed					
by USACE in 1966. [Additional Reference(s): DWR Levee Log, 2005.					
USACE San Joaquin O&M Manual 4, June 1968, (HLM 0.36)].					
FS Date: 9/11/2013

Concrete headwall on LS slope.

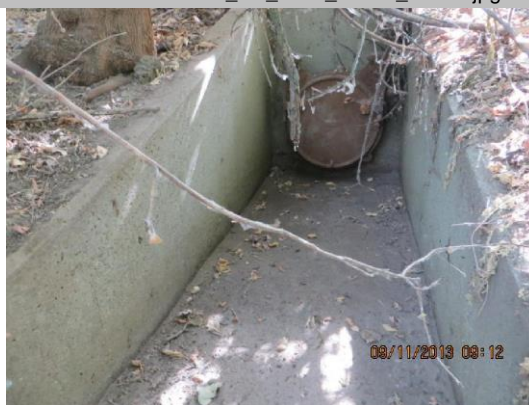
Photo 2 of 2 : UCIP_SP_2018_20024_33923.jpg

Concrete headwall and flapgate on WS toe.

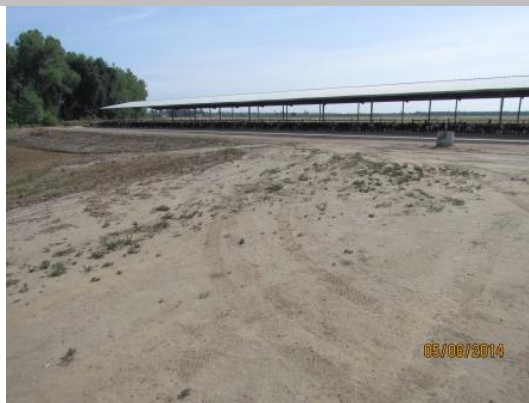
Photo 1 of 1 : SP_2018_RD2031_307_126_20180515_00041.jpg

View of the material placed on the waterside levee slope to build up the levee and increase the levee crown. Spring 2014.

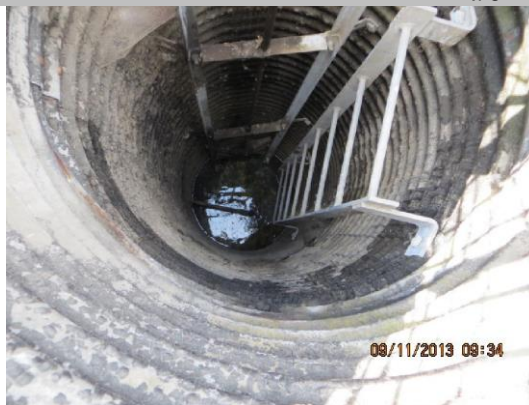
Photo 2 of 3 : UCIP_SP_2018_20044_33941.jpg

Slide gate in CMP riser on WS shoulder.

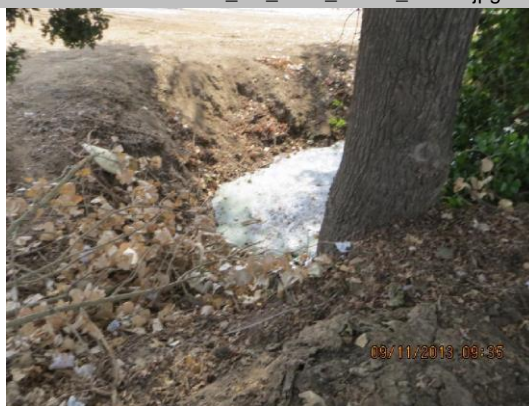
Photo 3 of 3 : UCIP_SP_2018_20044_33940.jpg

Drainage ditch at inlet on LS toe.

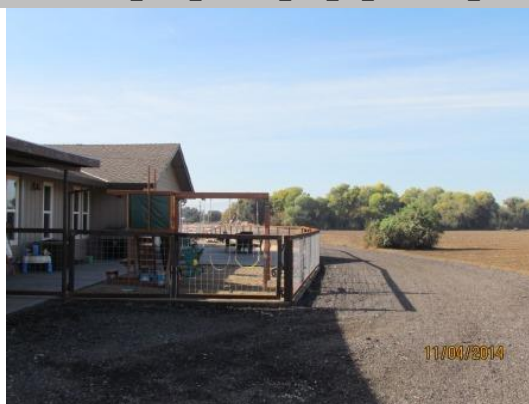
Photo 1 of 1 : SP_2018_RD2031_307_58_20180515_00035.jpg

LM Start	0.60	Rating **	M	Issue No.	58
LM End	0.63	Issue Type +	En	Location *	LS
Category	Earthen Levee			GPS Latitude/Longitude	
				Start	End
Item	Encroachments			37.703186 °	37.702786 °
				-121.160211 °	-121.160628 °
DWR ID	DWR_RD2031_01_f_2014_58				
Comment Code					
FE : Fence					
Inspector Comment					
Unpermitted fence on landside levee hinge.

View of the unpermitted fence on the landside levee hinge.

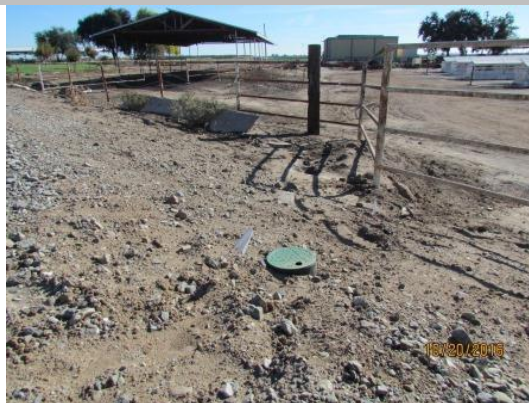
Photo 1 of 1 : SP_2018_RD2031_307_40_20180515_00022.jpg

View of the wire crossing the levee about 4 to 6 inches deep into the levee slope and crown. Irrigation box identifies the crossing location.

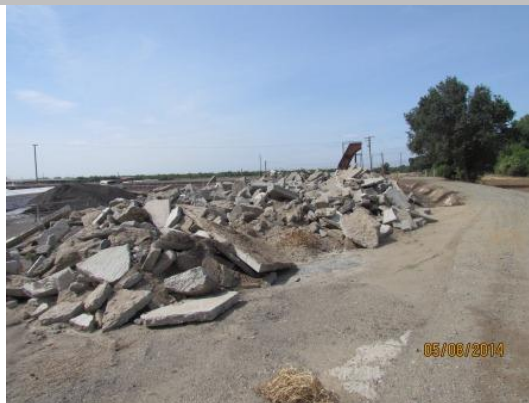
Photo 1 of 1 : SP_2018_RD2031_307_127_20180515_00042.jpg

View of the concrete debris stockpiled at the landside levee toe.

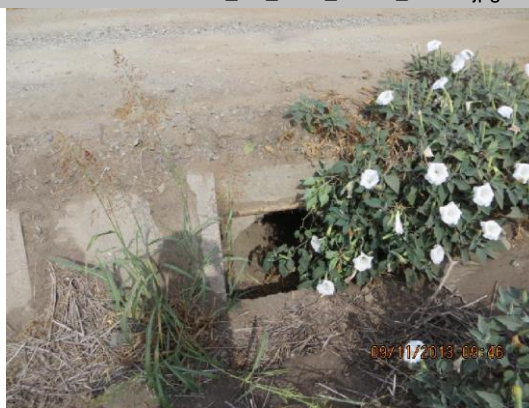
Photo 1 of 3 : UCIP_SP_2018_20046_33946.jpg

LM Start	0.72	Rating **	M	Issue No.	985
LM End	0.72	Issue Type +	En	Location *	
Category	Supplemental			GPS Latitude/Longitude	
				Start	End
Item	DWR UCIP Field Study			37.701912 °	37.701912 °
				-121.161642 °	-121.161642 °
DWR ID					
Comment Code					
Inspector Comment					
FS_ID:20046 DS_ID:20440 EP_NO: N/A Repair Type: Non-Urgent Crossing Status: Found UCIP Comments: Alfalfa valve on the WS toe is damaged. FIELD_STRUCT_DESC: 30-inch corrugated metal irrigation pipe through the levee, 5 feet below the crown. Flashboard slots in concrete headwall on the landside (LS). Distribution box with an alfalfa valve on the waterside (WS). Installed by USACE in 1966. Replaced a 30-inch pipe at the same location. [Additional Reference(s): DWR Levee Log, 2005. USACE San Joaquin O&M Manual 4, June 1968]. FS Date: 9/11/2013

Concrete headwall and pipe at concrete channel along landside shoulder of levee.

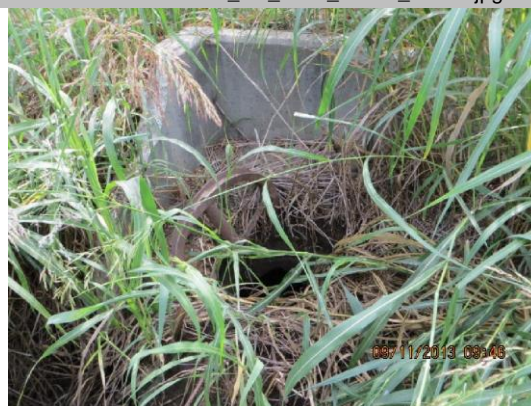
Photo 2 of 3 : UCIP_SP_2018_20046_33945.jpg

Concrete headwall and damaged alfalfa valve on WS toe.

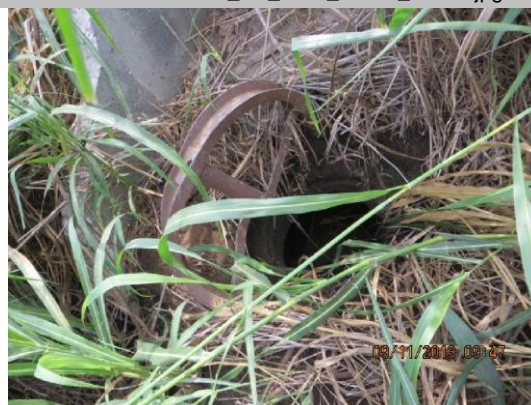
Photo 3 of 3 : UCIP_SP_2018_20046_33944.jpg

Damaged alfalfa valve.

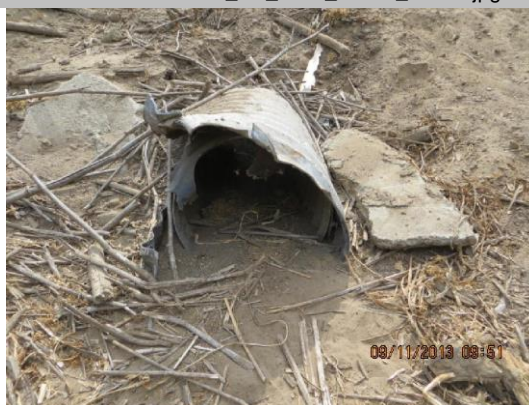
Photo 1 of 3 : UCIP_SP_2018_20047_33950.jpg

LM Start	0.75	Rating **	M	Issue No.	986
LM End	0.75	Issue Type +	En	Location *	
Category	Supplemental			GPS Latitude/Longitude	
				Start	End
Item	DWR UCIP Field Study			37.701552 °	37.701552 °
				-121.161883 °	-121.161883 °
DWR ID					
Comment Code					
Inspector Comment					
FS_ID:20047 DS_ID:20441 EP_NO: N/A Repair Type: Non-Urgent Crossing Status: Found UCIP Comments: This pipe appears abandoned and if so, should be done so appropriately. FIELD_STRUCT_DESC: 15-inch corrugated metal irrigation pipe through the levee, 4 feet below the crown. Flashboard slots on the landside (LS). Installed by USACE in 1966. [Additional Reference(s): DWR Levee Log, 2005. USACE San Joaquin O&M Manual 4, June 1968, (HLM 0.75)]. FS Date: 9/11/2013

Damaged CMP pipe on WS slope.

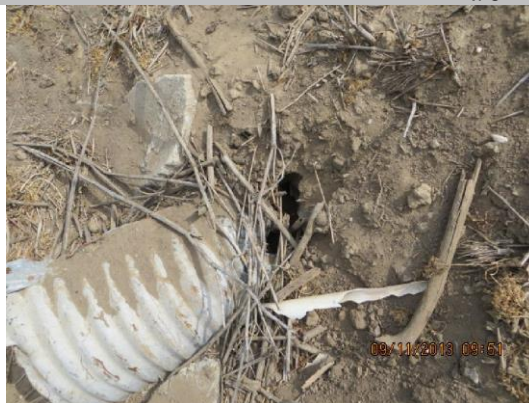
Photo 2 of 3 : UCIP_SP_2018_20047_33949.jpg

Hole in pipe at WS slope.

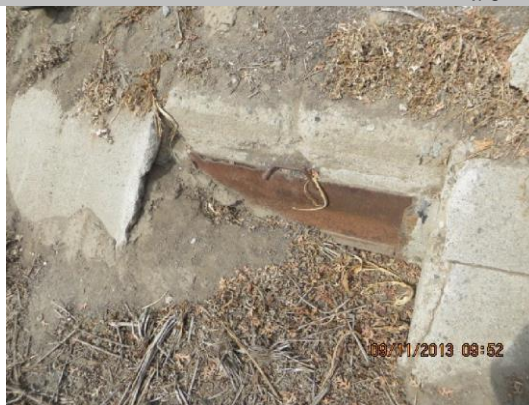
Photo 3 of 3 : UCIP_SP_2018_20047_33948.jpg

Closed slidegate at concrete headwall in concrete channel on LS shoulder.

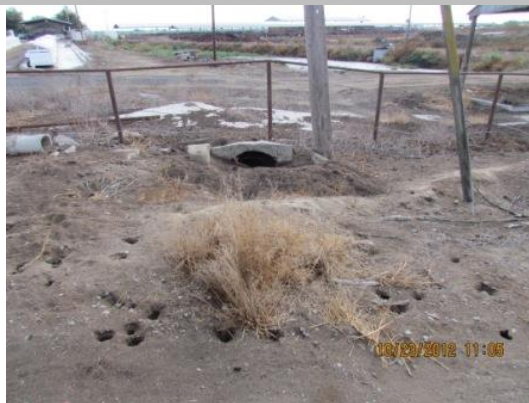
Photo 1 of 1 : SP_2018_RD2031_307_36_20180515_00019.jpg

View of rodent burrows on landside slope.

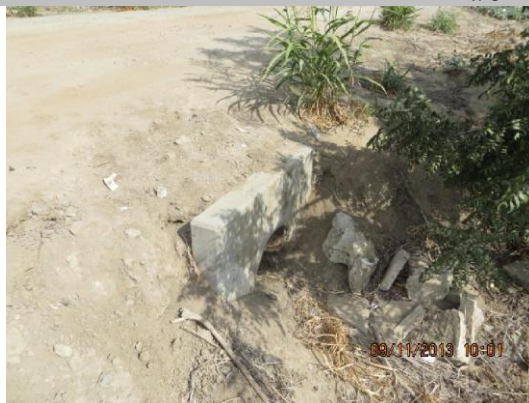
Photo 1 of 3 : UCIP_SP_2018_20049_33956.jpg

LM Start	0.80	Rating **	M	Issue No.	987
LM End	0.80	Issue Type +	En	Location *	
Category	Supplemental			GPS Latitude/Longitude	
				Start	End
Item	DWR UCIP Field Study			37.700853 °	37.700853 °
				-121.162349 °	-121.162349 °
DWR ID					
Comment Code					
Inspector Comment					
FS_ID:20049					
DS_ID:20443					
EP_NO: N/A					
Repair Type: Non-Urgent					
Crossing Status: Found					
UCIP Comments: Pipe appears abandoned as WS slope is covered with soil. If abandoned, it should be done so properly.					
FIELD_STRUCT_DESC: 24-inch steel irrigation pipe through the levee, 2 feet below the crown. Concrete headwalls on both sides of the levee crown. [Additional Reference(s): DWR Levee Log, 2005. USACE San Joaquin O&M Manual 4, June 1968, (HLM 0.81)].					
FS Date: 9/11/2013

Open pipe and headwall on LS slope.

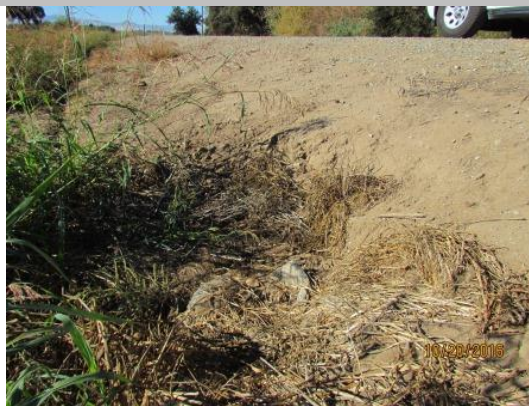
Photo 1 of 1 : SP_2018_RD2031_307_42_20180515_00023.jpg

LM Start	0.84	Rating **	M	Issue No.	42
LM End	0.84	Issue Type +	Ma	Location *	LS
Category	Earthen Levee			GPS Latitude/Longitude	
				Start	End
Item	Erosion / Bank Caving			37.700447 °	37.700447 °
				-121.162742 °	-121.162742 °
DWR ID	DWR_RD2031_01_f_2016_42				
Comment Code					
E2 : Schedule repair of erosion site prior to the next inspection.					
Inspector Comment

View of the erosion of the landside levee slope.

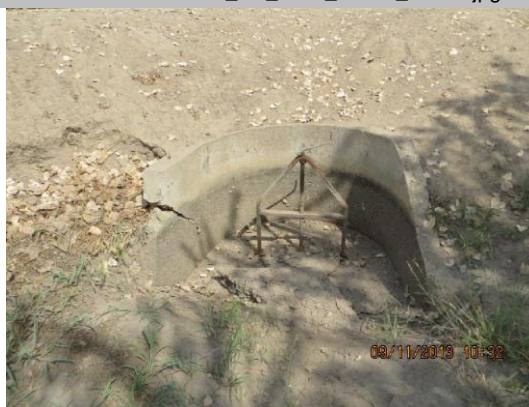
Photo 2 of 3 : UCIP_SP_2018_47158_74941.jpg

Front view of concrete structure located on landward toe.

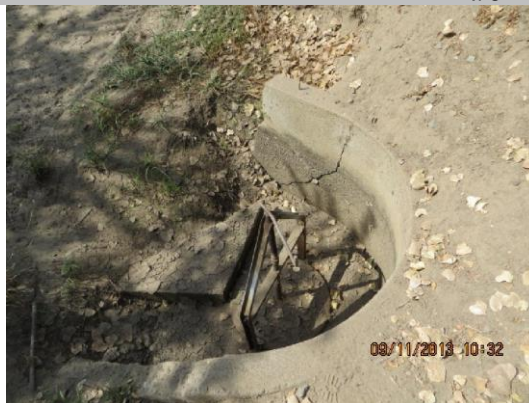
Photo 3 of 3 : UCIP_SP_2018_47158_74942.jpg

Structure buried with soil--no access.

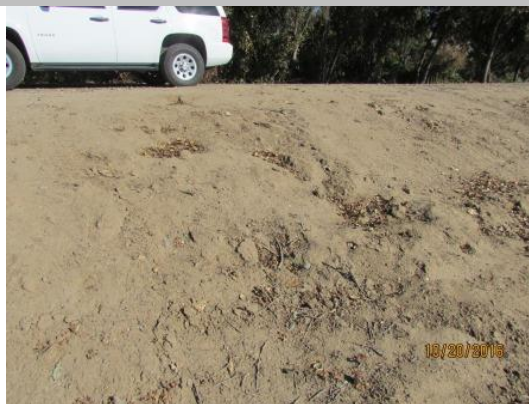
Photo 1 of 3 : SP_2018_RD2031_307_59_20180515_00036.jpg

View of the rodent holes on the landside levee slope.

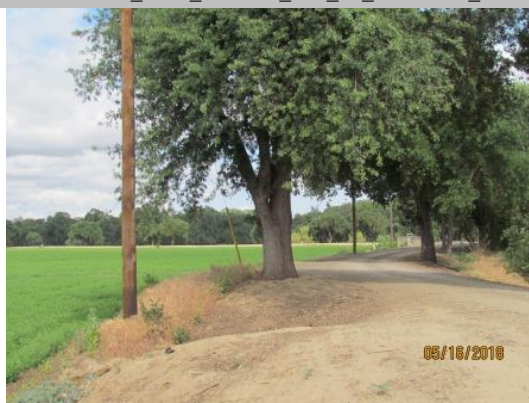
Photo 1 of 1 : SP_2018_RD2031_307_47_20180517_00108.jpg

View looking downstream landside of three power poles on the levee and levee slope.

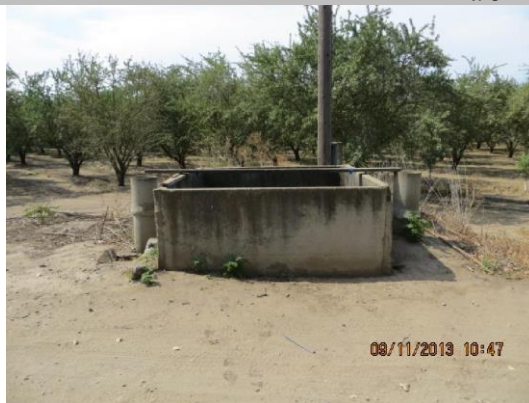
Photo 1 of 3 : UCIP_SP_2018_20085_34010.jpg

LM Start	1.27	Rating **	M	Issue No.	989	
LM End	1.27	Issue Type +	En	Location *		
Category	Supplemental			GPS Latitude/Longitude		
				Start		End
Item	DWR UCIP Field Study			37.699480 °		37.699480 °
				-121.169850 °		-121.169850 °
DWR ID						
Comment Code						
Inspector Comment						
FS_ID:20085 DS_ID:20445 EP_NO: N/A Repair Type: Non-Urgent Crossing Status: Found UCIP Comments: Pipe corroded through at distribution box. Appears abandoned and should be done so properly. FIELD_STRUCT_DESC: 1 of 2: 12-inch steel irrigation pipe through the levee, 3.3 feet below the crown. Pump missing from pile structure on the riverbank. Concrete distribution box on the landside (LS). Installed by USACE in 1966. [Additional Reference(s): DWR Levee Log, 2005. USACE San Joaquin O&M Manual 4, June 1968, (HLM 1.28)]. FS Date: 9/11/2013

Concrete distribution box on LS shoulder.

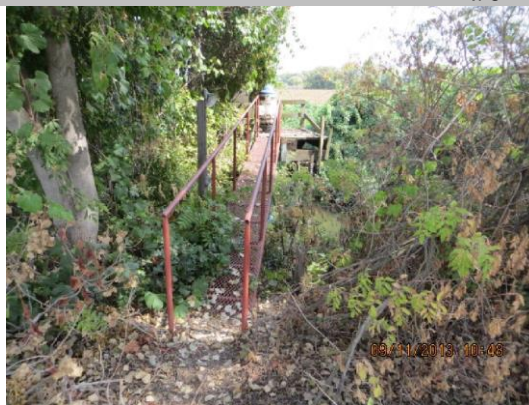
Photo 2 of 3 : UCIP_SP_2018_20085_34009.jpg

Pump on pier on WS slope.

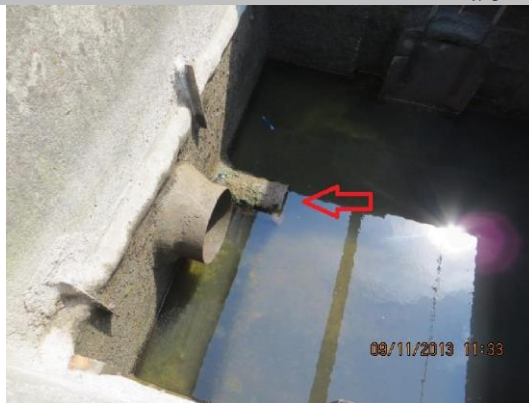
Photo 3 of 3 : UCIP_SP_2018_20085_34008.jpg

Pipe visible inside concrete distribution box on LS shoulder.

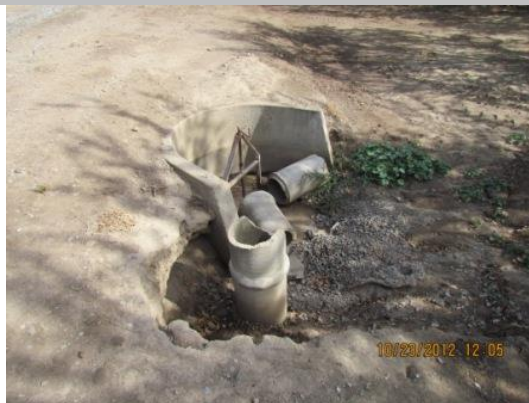
Photo 1 of 2 : SP_2018_RD2031_307_3_20180515_00001.jpg

View of the erosion site on landside slope, facing upstream.

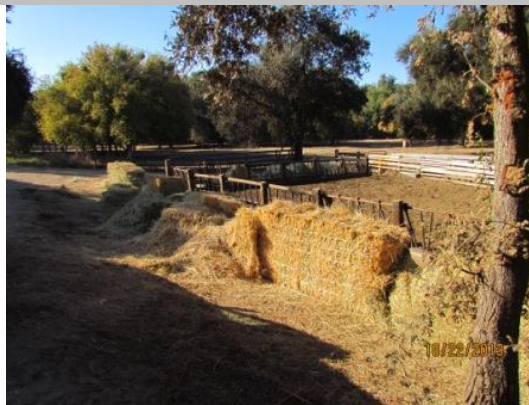
Photo 1 of 1 : SP_2018_RD2031_307_37_20180515_00020.jpg

View of the hay bails at the waterside levee toe.

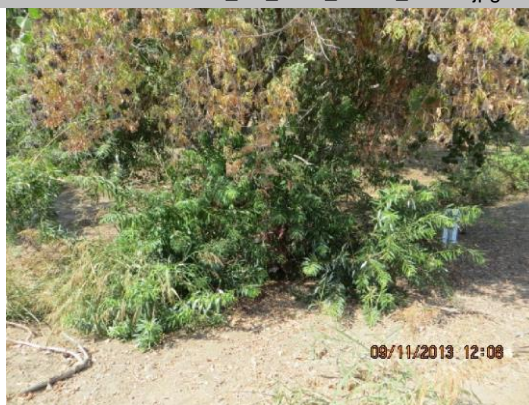
Photo 2 of 3 : UCIP_SP_2018_20110_34077.jpg

Vegetation covers outlet of pipe on WS slope.

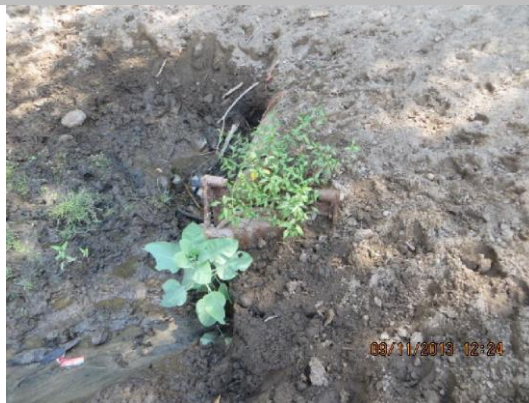
Photo 3 of 3 : UCIP_SP_2018_51340_39001.jpg

Flapgate partially blocked by soil on WS toe.

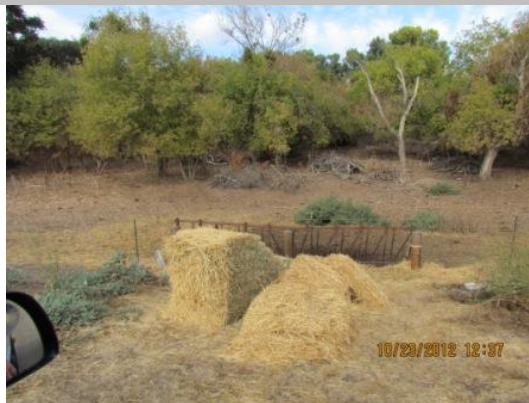
Photo 1 of 1 : SP_2018_RD2031_307_45_20180515_00027.jpg

View of hay bales at toe of levee on waterward side, facing downstream.

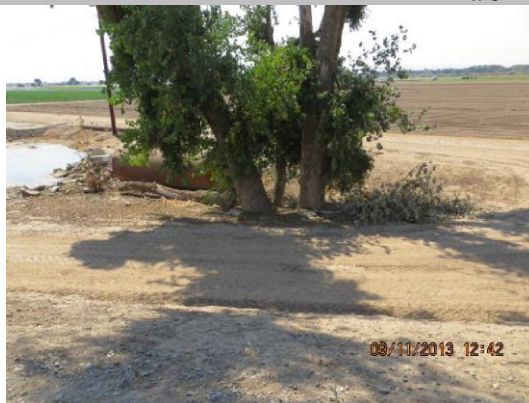
Photo 2 of 3 : UCIP_SP_2018_20449_34505.jpg

Pipe not visible on LS toe.

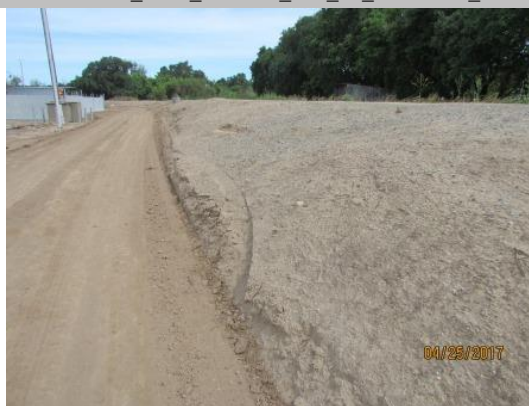
Photo 1 of 1 : SP_2018_RD2031_307_55_20180515_00033.jpg

View of the levee toe cut. Looking downstream.

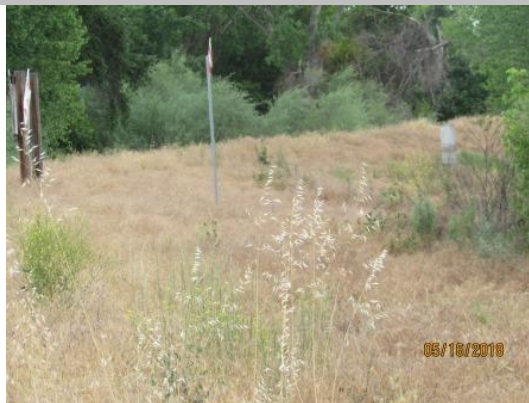
Photo 1 of 1 : SP_2018_RD2031_307_56_20180517_00113.jpg

View looking upstream of the levee where the annual vegetation through the wild life persevere need to be maintained on the crown, landside, and waterside, Spring 2018.

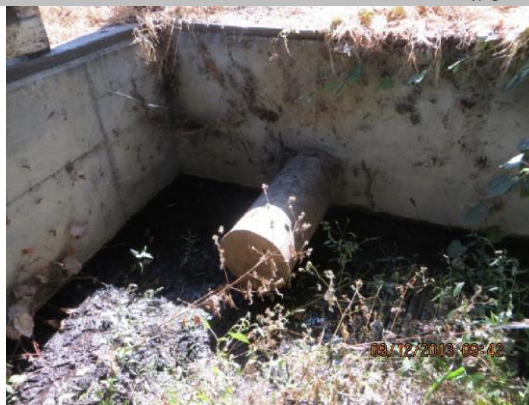
Photo 2 of 3 : UCIP_SP_2018_20683_34781.jpg

Welded steel plate over WS end of pipe.

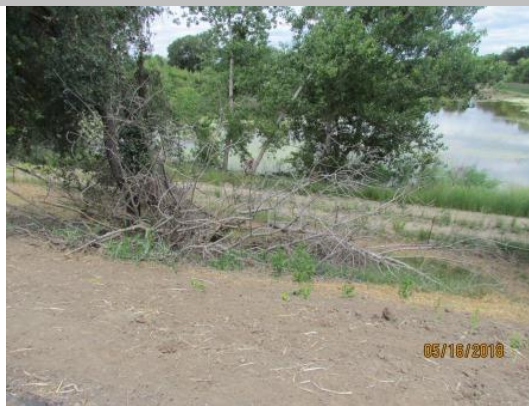
Photo 1 of 1 : SP_2018_RD2031_308_18_20180517_00051.jpg

View of a fallen tree on the landside levee slope that needs to be removed, Spring 2018.

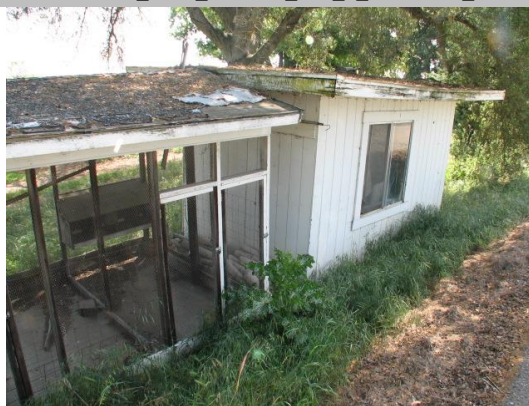
Photo 1 of 1 : SP_2018_RD2031_308_4_20180515_00005.jpg

Small structure on levee slope is permitted under Permit No. 5793.

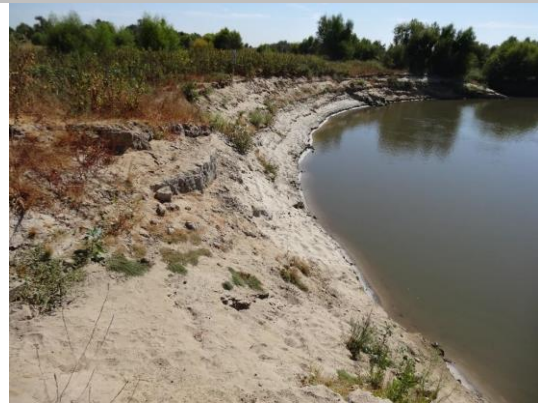
Photo 1 of 4 : SP_2018_RD2031_308_1_20180515_00001.jpg

Looking upstream of the erosion site.

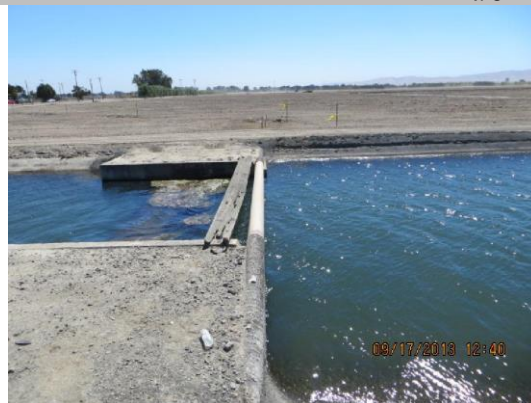
Photo 2 of 2 : UCIP_SP_2018_20745_34960.jpg

Gasline visible at crossing.
